Repair of a steam turbine in Thailand using pulsed laser beam welding

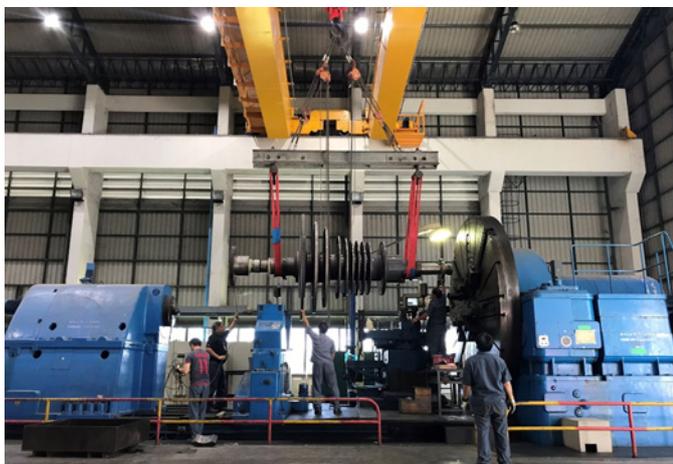
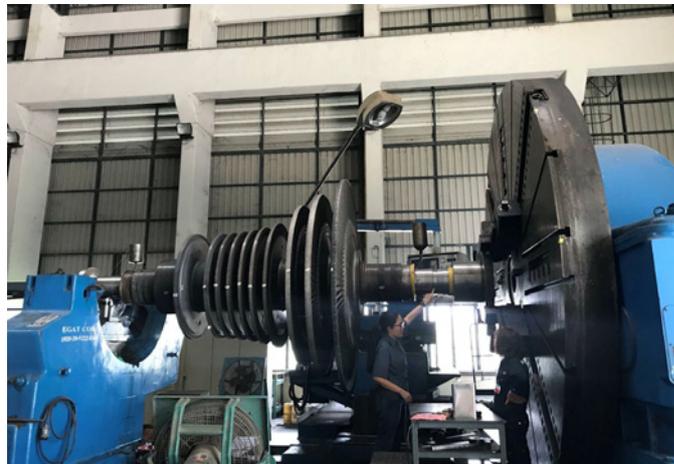
Fig. 1 • Placing the turbine rotor on the head lathe for mechanical pre-machining of the damaged surfaces.

The rotor repaired by DSI (Thailand) (Fig. 1) is the rotor of a steam turbine built by Siemens in 2005. The 37 MW turbine is

The rotor of the turbine is oil-bearing. Due to a faulty operation during the operation of the turbine, a "deficient lubrication" occurred, i.e. an insufficient, "tearing off" lubricating film between the rotor shaft, which rotates at 3,000 revolutions per minute, and its mountings. The metallic friction and the resulting heat development caused cracks at both rotor shaft ends. After an initial damage assessment, cracks up to a depth of 2 mm were expected. Cracks up to a depth of 7 mm were found during the subsequent magnetic particle inspection (MT inspection) and during mechanical machining of the flaws on a head lathe.

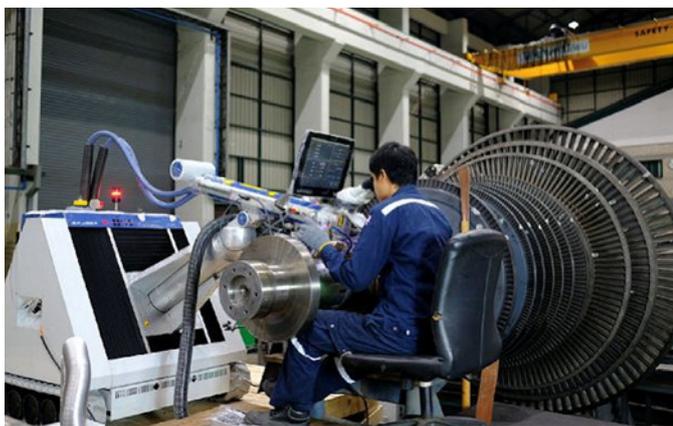
Fig. 2 • The Nd:YAG pulsed laser welding machine "900W ALFlak fibre" from the German manufacturer Alpha Laser in the welding application at the turbine rotor in Thailand.

EGAT, was used as welding filler. The laser used was a Nd:YAG pulsed laser welding machine (Fig. 2) with an average laser output power of 900 W. The wavelength was 1,059 nm. The welding was performed with a pulse frequency of 33.6 Hz, a pulse duration of 3.5 ms, a beam diameter of 2.5 mm and the shielding gas Ar 99.9%. A pWPS (pWPS-DSI-EGAT-Turbine-18.11.12) was available with all further necessary data. The DSI (Thailand) laser beam welders

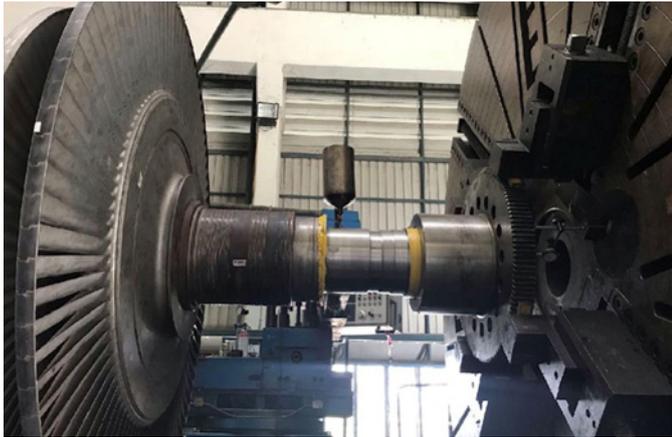
Fig. 3 • The turbine shaft mechanically prepared for welding.

After cleaning, the machining surfaces were machined to a depth of 2 mm in the crack area over a width of 332 or 340 mm and an additional 5 mm deep in the direct crack area over a width of 100 mm (Fig. 3).

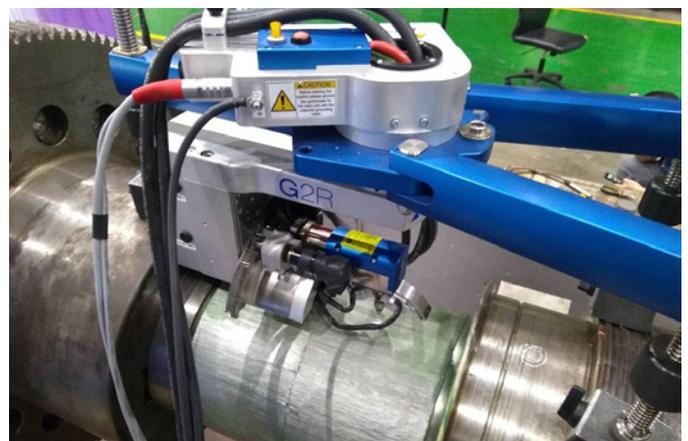
Fig. 4 • The measuring device installed before and during welding for stress testing of the turbine shaft.

In order to determine possible component stresses, a stress test was carried out using the "Residual Stress Measurement" method based on the "X-Ray-Diffraction" technique, in each case before, in intermediate steps during and after welding (Fig. 4). The welding on the turbine rotor on site in Thailand is shown in Fig. 5.

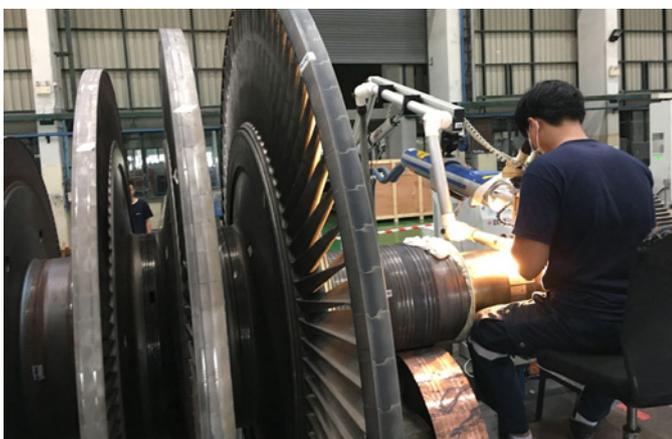
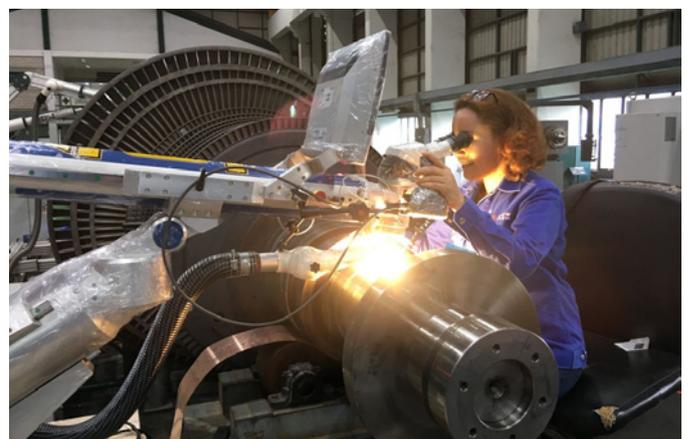
Fig. 5 • On-site welding on the turbine rotor.

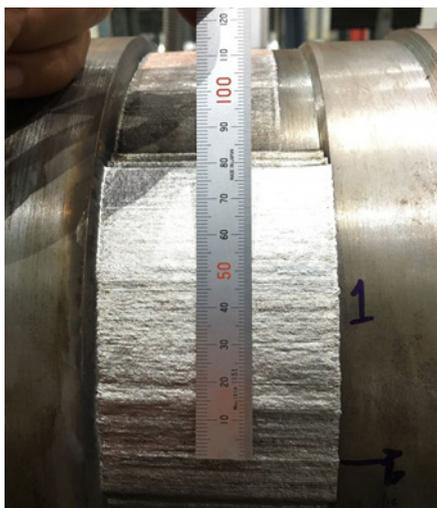
Fig. 6 • Layer structure of the pulsed laser beam repair welding.

The thickness of the seam applied in each layer was about 1 mm. In the direct crack area of the shaft (100 mm wide) there were approx. five to six circumferential layers, on the surface (332 or 340 mm) there were three layers.

From an economic/temporal point of view, this wide-area and large-volume repair welding was only possible by using two 900 W fibre lasers, which were used to weld simultaneously at both shaft ends. An interlayer result is shown in

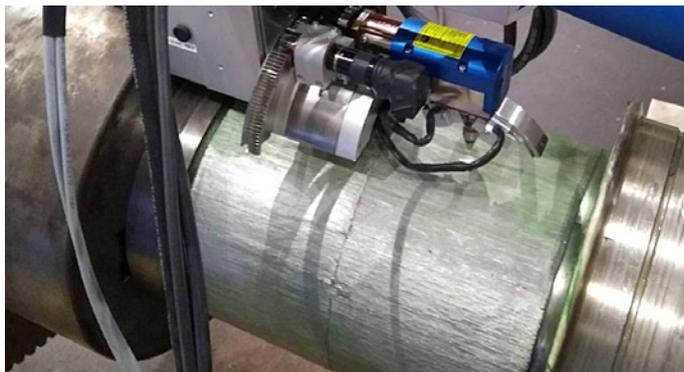
Fig. 7 • The finished pulsed laser beam weld during the final stress check.

Fig. 6. In addition to the final stress tests and visual inspections (VT), the finished welds (Fig. 7) were also tested by means of dye penetrant testing (PT), magnetic particle testing (MT) and ultrasonic testing (UT). After the successful tests, the welded surfaces at the rotor shaft ends were machined on a head lathe to the original dimensions and tolerances determined for their use.

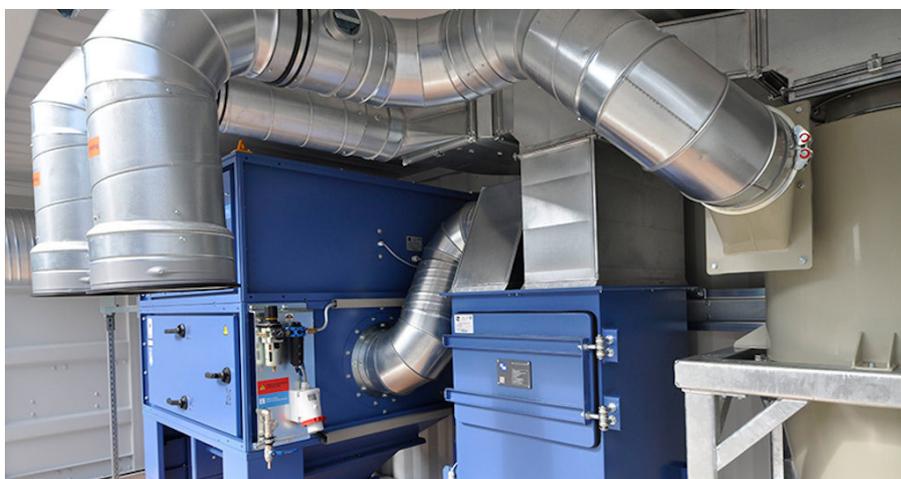
The "ZPF" suction and filter system is able to extract and clean large volumes of contaminated air: Two sets of pipework – one for welding fumes and the other for dust from grinding work – extract the contaminated air and guide it via the pre-separators to the filter unit.
